The Importance of a Proper Passdown

By AE3 Robert Dubrasky

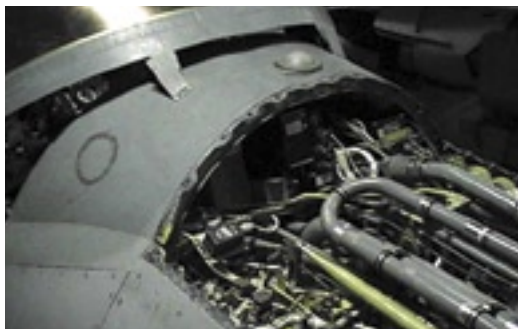
Top-deck relay is found under the turtle back panel.

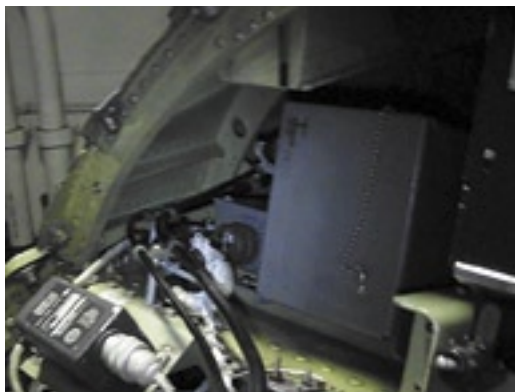
No. 1 relay and No. 2 relays are similar.

It wasn't long before the part was received, and the night shift began their workday with the usual passdown, or so it seemed at the time. They removed and replaced the relay box. After doing an operational check of the system, they discovered that the downing discrepancy wasn't fixed. Night-check then began to troubleshoot the system to find the problem. After a closer look at the schematics, we discovered that we had changed the wrong top-deck relay box. We had changed the No. 1 relay box instead of No. 2.

It's common for EA-6B electricians to change the No. 1 relay box but not the No. 2 box. When the electricians saw the gripe and ordered a replacement, they incorrectly assumed it was the No. 1 component.
